## ABBREVIATED PRELIMINARY ASSESSMENT CHECKLIST

The Coney Island Electroplating Works (CIEW) site consists of a former electroplating facility near Coney Island Creek in Brooklyn, NY. U.S. Environmental Protection Agency (EPA) discovery of the CIEW site occurred in 2020 during the Site Discovery Initiative associated with the Coney Island Creek site, which is considered to be a sediment plume with multiple possible sources of contamination. The CIEW site is being evaluated as one of the possible sources. The subject property has been utilized for industrial purposes, including laundry, lumber, electroplating, and auto repair, since at least 1924. The entirety of the on-site building was previously occupied by CIEW (also called Ruspantini Ermete Electroplating in city directories). Electroplating operations took place from the 1940s until the early 1990s. The two-story brick building that was previously occupied by the electroplating works is currently subdivided into two storefronts occupied (from north to south) by Stillwell Plumbing Supply and YBC Auto Group. The site is located in a densely industrial area of Brooklyn, with numerous automotive repair shops and auto body shops l

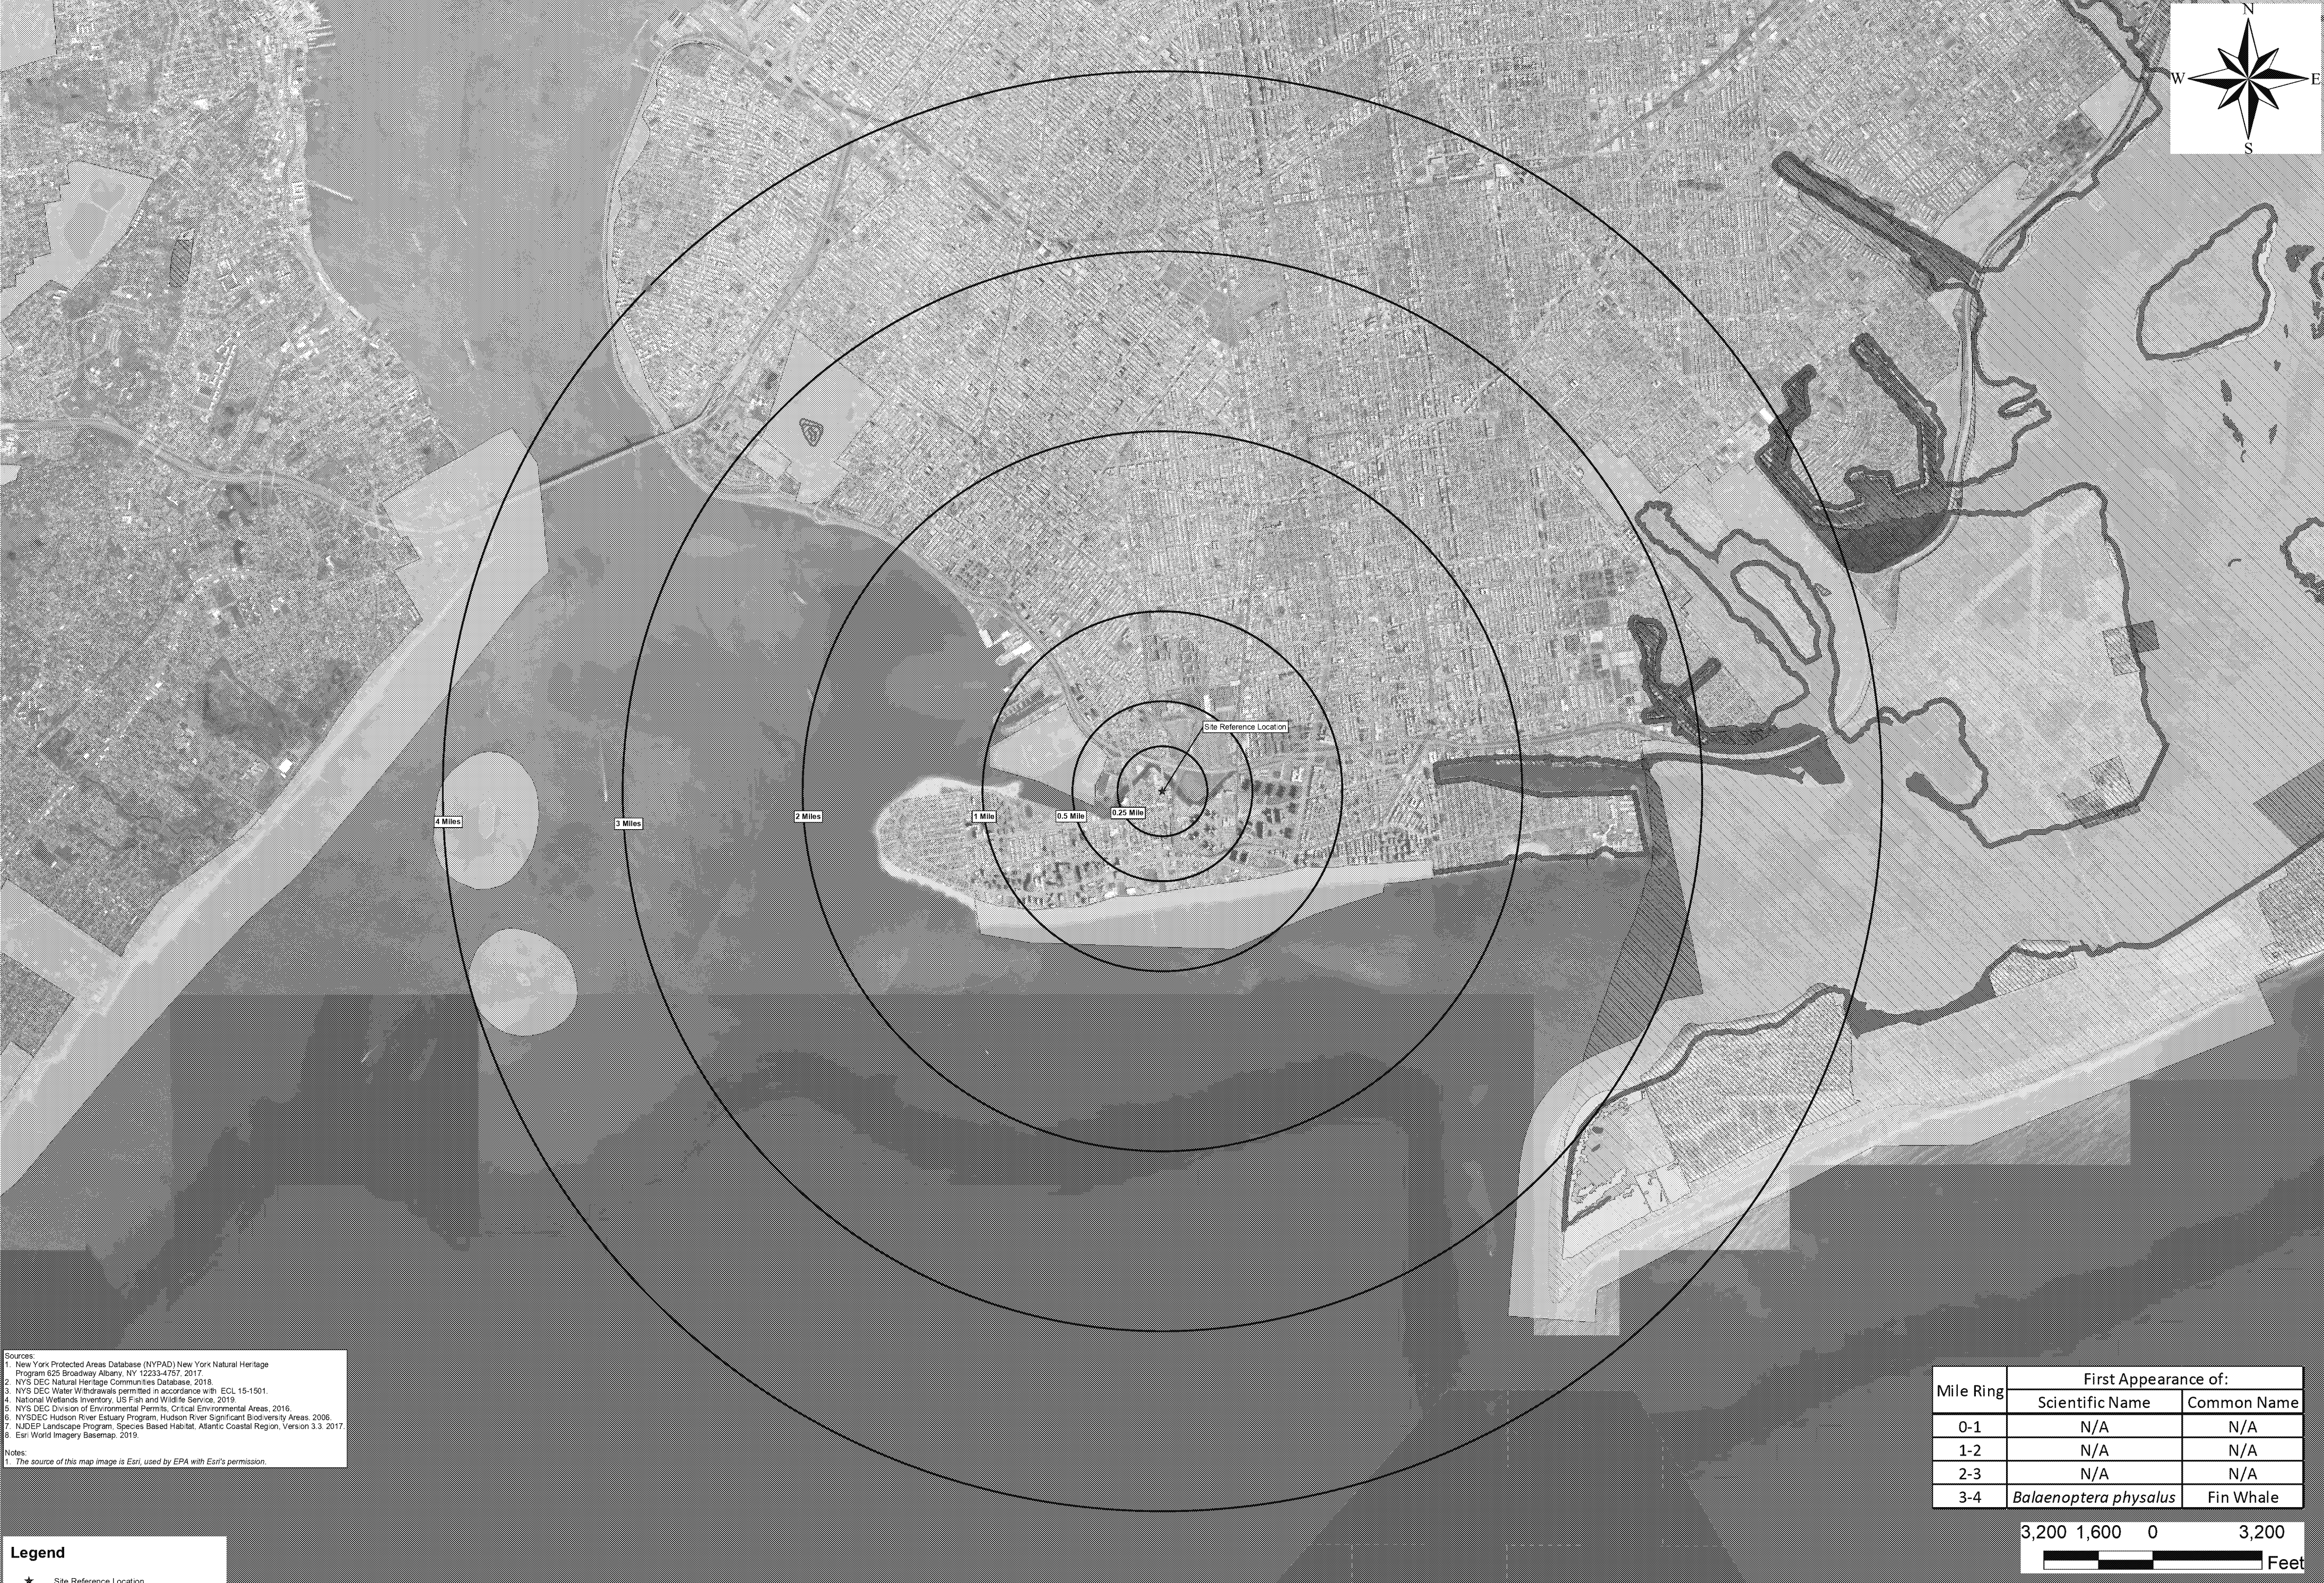
Sources:  
1. New York Protected Areas Database (NYPAD) New York Natural Heritage Program 625 Broadway Albany, NY 12233-4757, 2017.  
2. NYS DEC Natural Heritage Communities Database, 2018.  
3. NYS DEC Water Withdrawals permitted in accordance with ECL 15-1501.  
4. National Wetlands Inventory, US Fish and Wildlife Service, 2019.  
5. NYS DEC Division of Environmental Permits, Critical Environmental Areas, 2016.  
6. NYSDEC Hudson River Estuary Program, Hudson River Significant Biodiversity Areas, 2006.  
7. NJDEP Landscape Program, Species Based Habitat, Atlantic Coastal Region, Version 3.3, 2017.  
8. Esri World Imagery Basemap, 2019.

- Legend**
- ★ Site Reference Location
  - ★ Approximate Probable Point of Entry
  - ▲ Mile Markers
  - 15-Mile Pathways
  - ▨ HRS-Eligible Wetlands
  - Critical Environmental Areas
  - NYSDEC-designated Natural Heritage Sites
  - NY Protected Areas Database
  - ▨ Hudson River Significant Biodiversity Area
  - NJDEP Species-Based Habitat Rank**
  - Rank 3 - State Threatened
  - Rank 4 - State Endangered
  - Rank 5 - Federal Listed

Miles Downstream of PPE	First Appearance of:		
	Scientific Name	Common Name	Waterbody
4-5	<i>Acipenser brevirostrum</i>	Shortnose Sturgeon	Upper Bay
7-8	<i>Balaenoptera physalus</i>	Fin Whale	Atlantic Ocean
8-9	<i>Nycticorax nycticorax</i>	Black-crowned Night-heron	Newark Bay
9-10	<i>Pandion haliaetus</i>	Osprey	Kill van Kull
10-11	<i>Caretta caretta</i>	Atlantic Loggerhead	Raritan Bay
11-12	<i>Pontia protodice</i>	Checkered White	Newark Bay
12-13	<i>Rynchops niger</i>	Black Skimmer	Raritan Bay
13-14	<i>Haliaeetus leucocephalus</i>	Bald Eagle	Arthur Kill
14-15	<i>Bubulcus ibis</i>	Cattle Egret	Arthur Kill

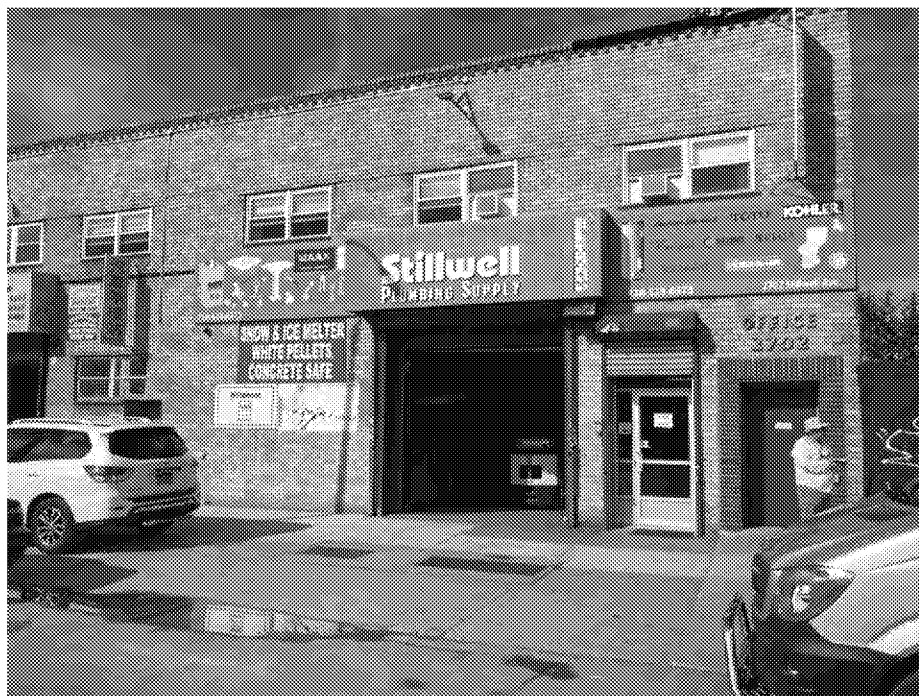
Photo No. 1: Storefront and sign of current site occupant, Stillwell Plumbing Supply, located at 2702 Stillwell Avenue, the former location of Coney Island Electroplating Works (CIEW); looking west. Vacant land to the north is fully fenced by green fencing, at right of photo.

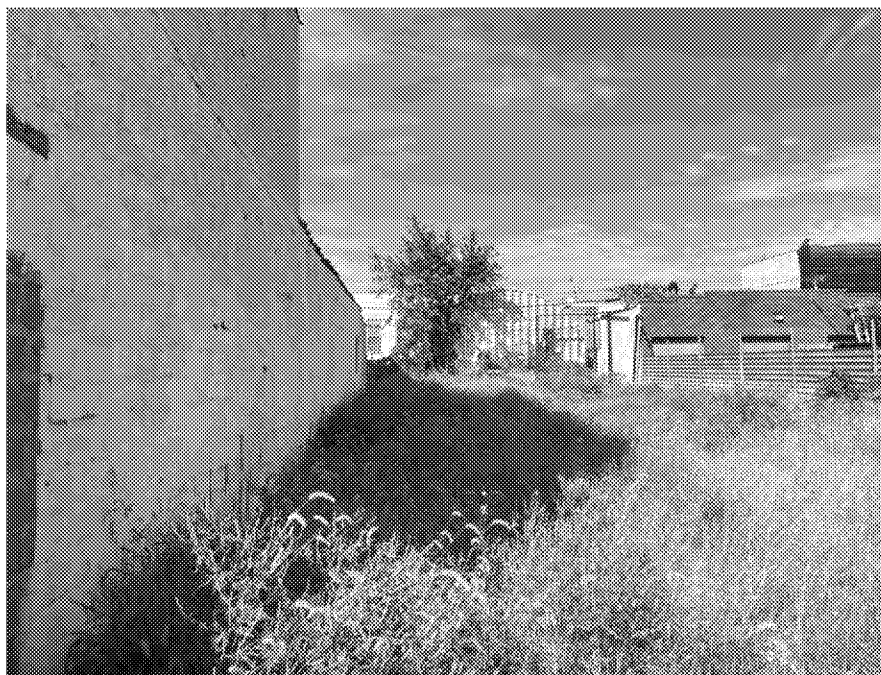
Photo No. 2: Vacant land bordering site to the north; northern wall of the brick building occupying the CIEW site at the left. Land fully fenced; no staining, stressed vegetation, or containers observed on the property. Looking west.

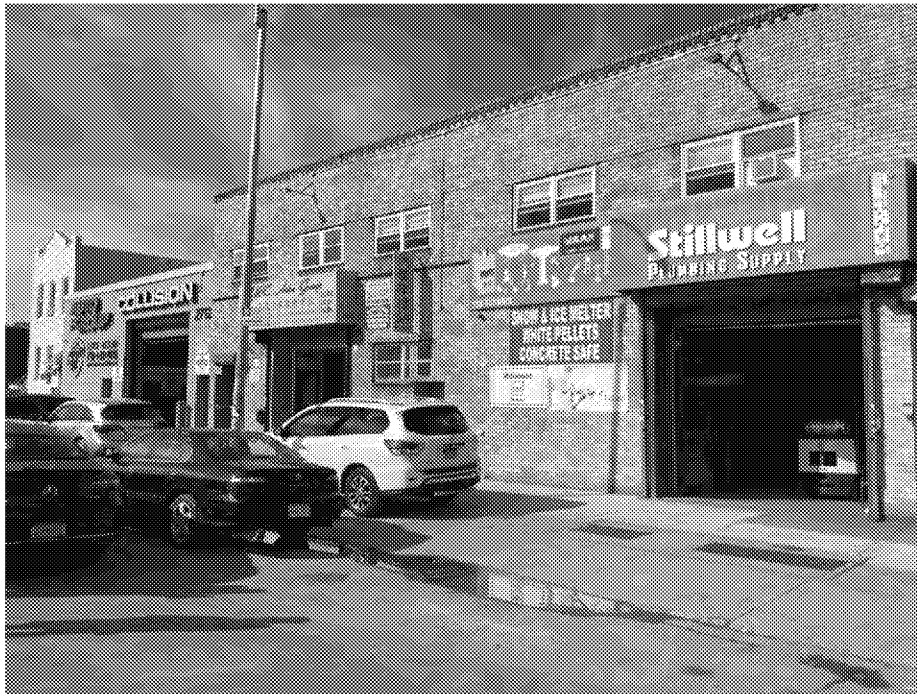
Photo No. 3: Stillwell Plumbing Supply is located in a two-story brick building, occupied by a second storefront to the south, an auto mechanic shop. Looking southwest.

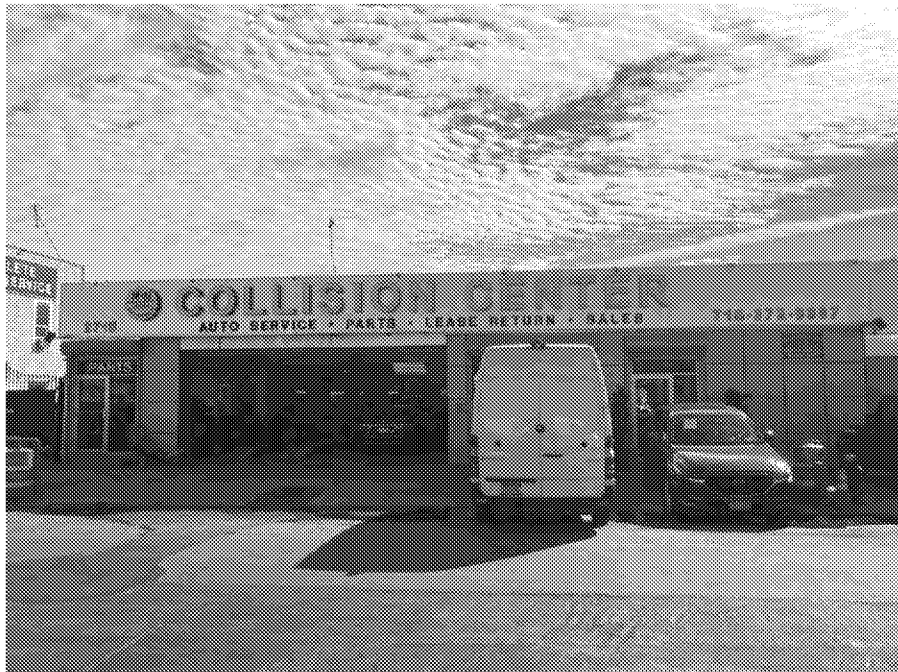
Photo No. 4: M&N Collision Center is located directly east of the site, across Stillwell Ave. The majority of Stillwell Ave is occupied by auto mechanics and auto supply stores (tires and car parts, new and resale). Looking east.

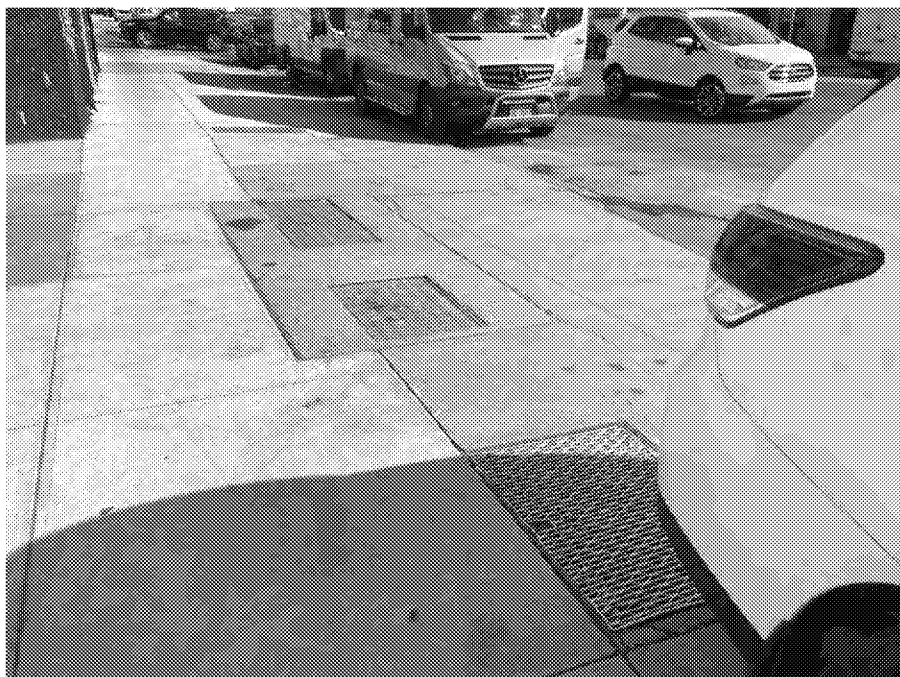
Photo No. 5: Grates located in the sidewalks directly outside 2702 Stillwell Ave. The nearest storm sewer is located south of the site in the western side of Stillwell Ave.

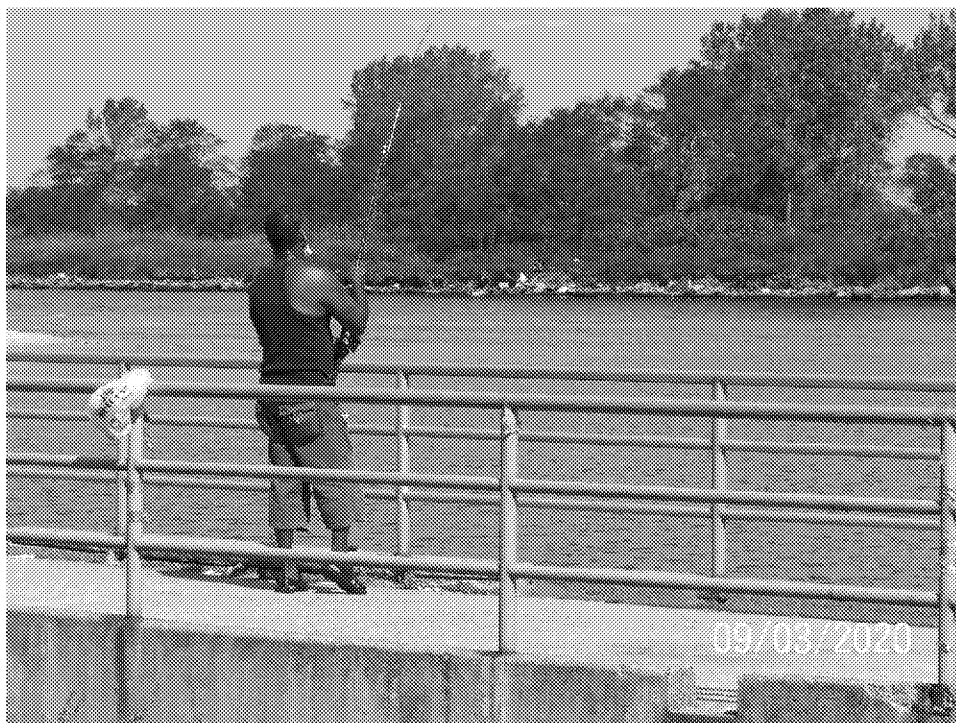
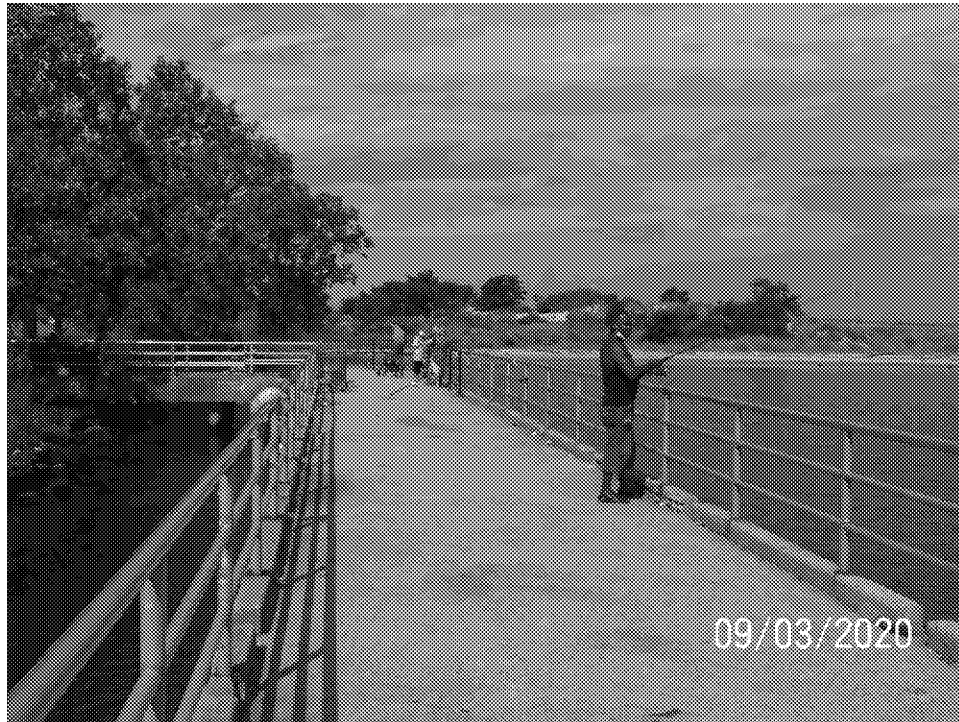
Photo Nos. 6 and 7: Multiple persons were observed to be fishing for consumption along the south side of Coney Island Creek at the Kaiser Park fishing pier. According to these residents, species of fish caught for consumption include blue fish, striped bass, and flounder. Resident at the far end of the pier was using both a fishing pole and a net.
